On-Rope Repairs To Live Service Water Lines

At an LNG facility in Western Australia, through-wall defects were discovered on service water lines. To avoid shutdown of the lines, a repair solution was required that could address the defects while encompassing the existing temporary repairs.

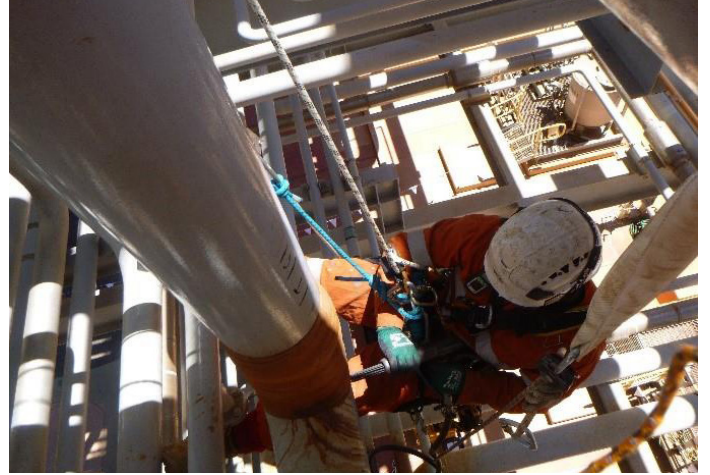
The repairs were completed on ropes by ICR IAS JV Application Specialists

- Temporary repairs were not removed and were instead treated as defects, allowing for live line repairs without additional leak sealing requirements
- 12 layers of Technowrap™ 2K glass fibre was applied, adhering to prepared surfaces adjacent to each defect and providing a 19-year design life
- As scaffolding was deemed impractical, repairs were completed on ropes by ICR IAS JV Application Specialists

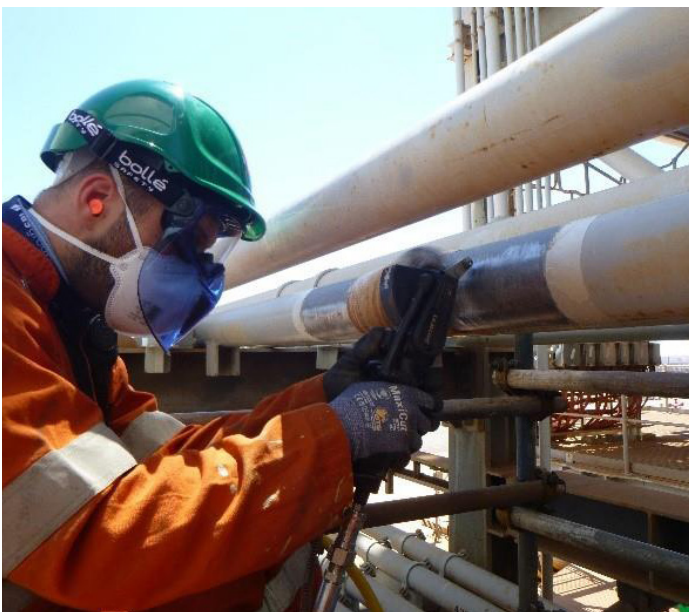
Temporary repair wraps were left in place, allowing the lines to remain active

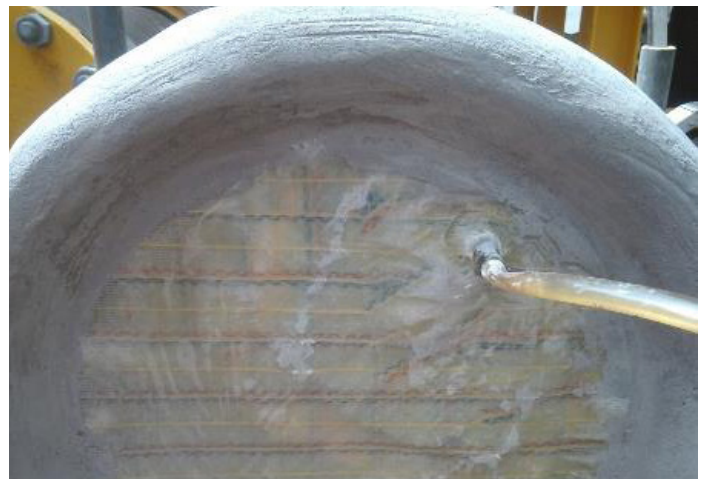
The engineered repairs were designed for a 19-year life, matching the lifetime of the original piping
