Live Leak Seal on a GRE Seawater Header Line

An offshore gas processing facility in Western Australia experienced localised internal erosion, resulting in a through-wall defect on the flanged interface of a GRE Seawater Header Line.

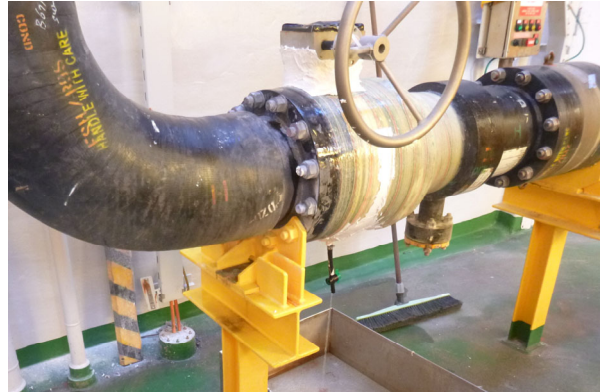
Leak diversion in place

A live leak seal was installed with a flow diversion plate to ensure there was no loss of production through shutting down whilst the engineered composite repair was applied.

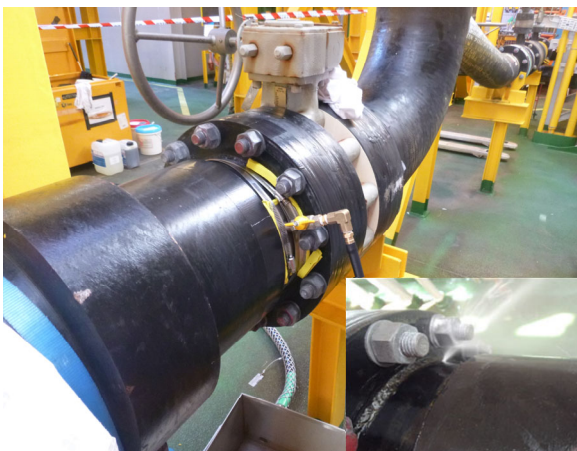
Repair location

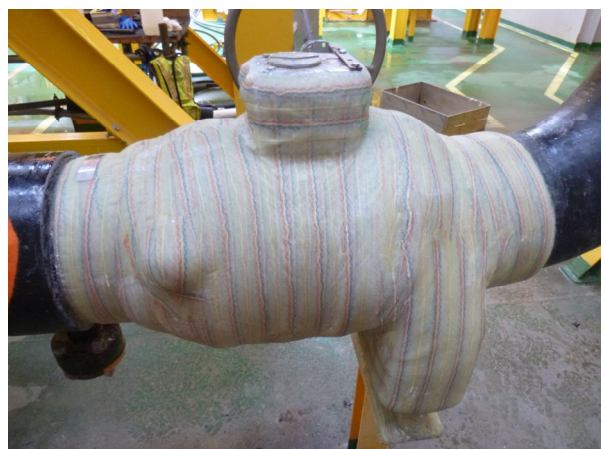
Completed repair

- Technowrap™ 2K glass fibre was used which enables existing inspection systems to continue to be used
- Quick response with engineering completed and mobilization to site in a short timeframe
- Flow diversion used to ensure a dry surface throughout the duration of the repair
