## Technowrap™ Long-term repair to a buried oil supply line.

### Overview

The client contacted ICR.IAS JV about significant internal corrosion defects on the underground oil supply line. The repair strategy and landing were also designed to include a previous non-Technowrap™ composite repair.

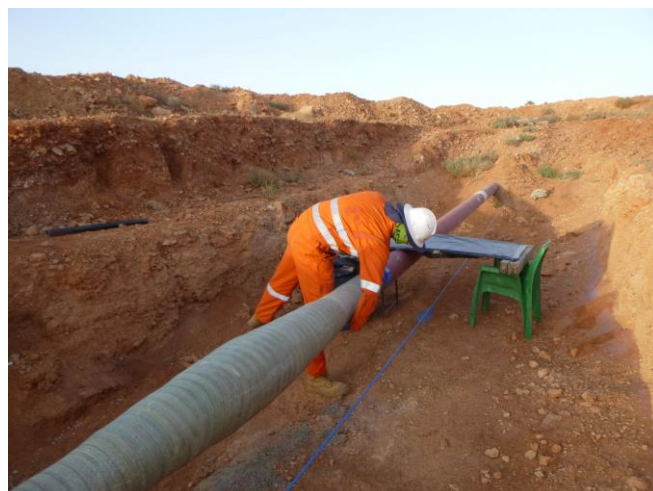
Application of the Technowrap™ Repair

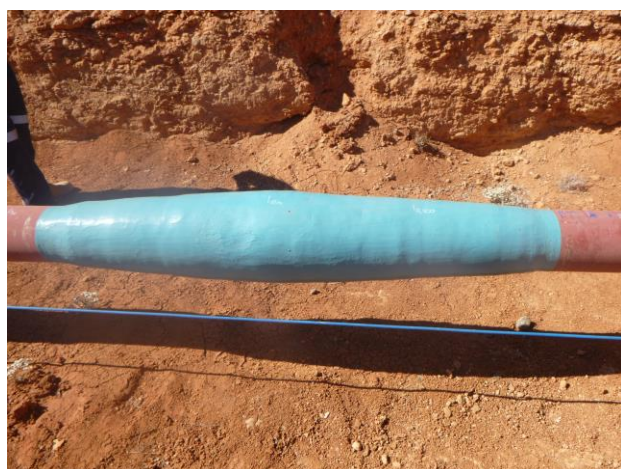
Previous composite repair - internal corrosion defects identified at either end of the repair.

- Technowrap™ 2k Glass Fibre with HA Resin system was chosen due to the design temperatures and location requirements.
- Wrapping over the existing non-Technowrap™ repair was necessary due to the location of the defects.
- Challenging working environment with ambient temperatures exceeding 40°C causing shorter working times with resin. This was mitigated with improved work setup to suit faster application.

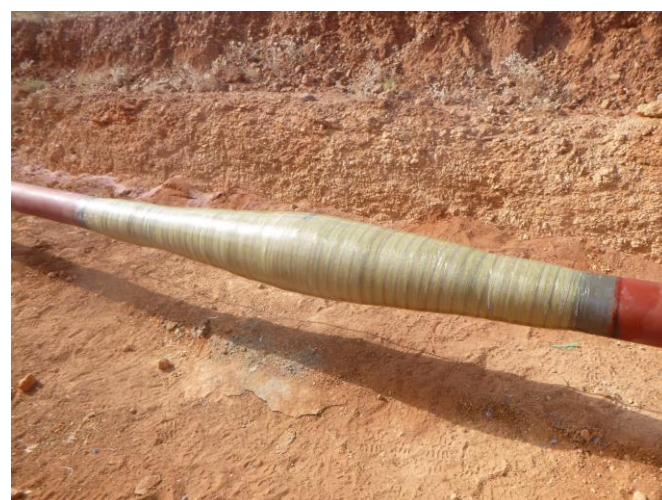
Completed Technowrap™ Repair

ICR.IAS JV applied a 14-layer Technowrap™ 2k Glass Fibre repair to numerous defect locations.
