Partial Cover of Clamp on Crude Header Line

Overview

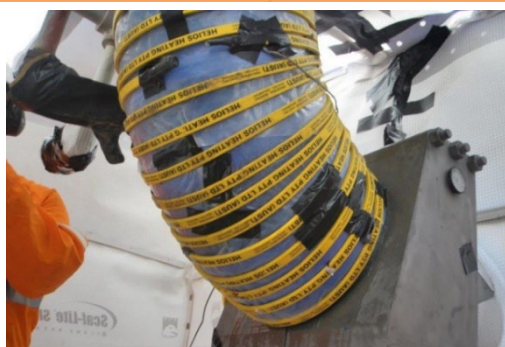
Heat tape to assist with cure speed

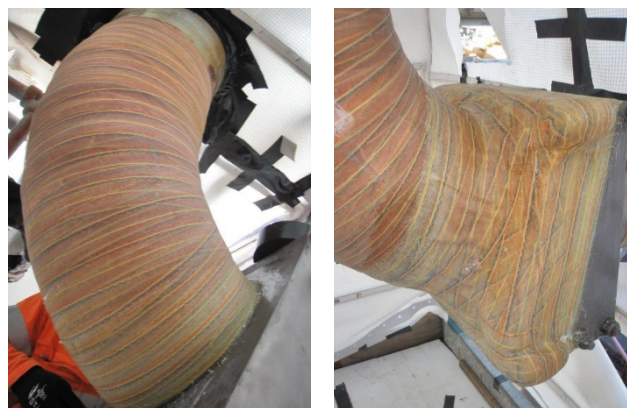
Technowrap 2K™ HT applied to elbow and clamp

- The high design temperature necessitated using the Technowrap 2K™ High Temperature (HT) system
- Wrap applied to both the corroding elbow and the adjacent metal clamp to ensure sufficient bonding
- Heat tape required for elevated temperature cure
- Rapid delivery of repairs (24 hours)

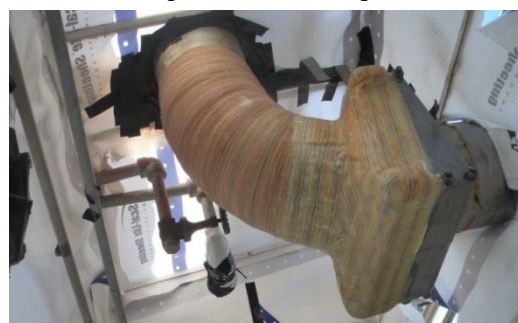
Technowrap 2K™ HT completed repair
