Composite Repair Of A High Temperature Fuel Gas Line

OVERVIEW

At an offshore facility in Western Australia, internal and external corrosion was discovered on a high temperature fuel gas line. A repair solution was required that could provide structural remediation and withstand high temperatures over a 20-year design life.

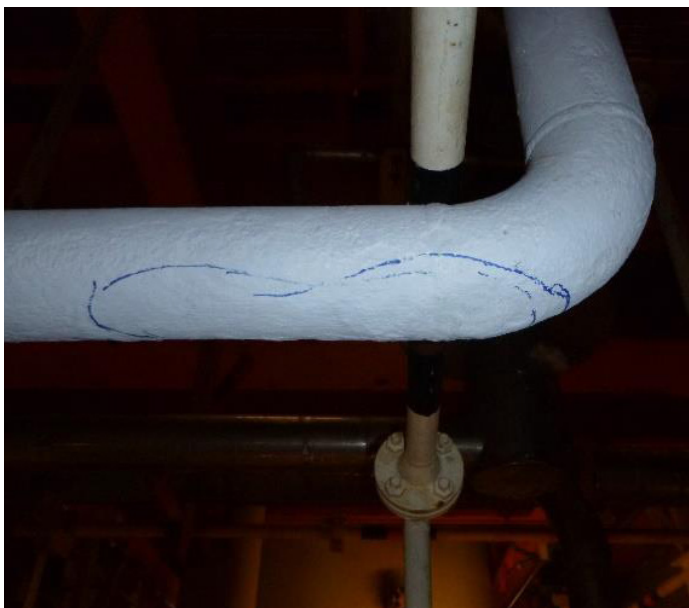
Structure	Pipe elbow
Surface Preparation	ST3
Design Pressure	3.5 bar
Design Temperature	-6°C - 204°C
Application Temperature	25°C
Design Life	20 years
Repair Length	564mm
Pipe Diameter	60.3mm
Damage Mechanism	Internal and external corrosion
Defect Details	300 mm Circumferential (through wall)

Reduced wall thickness was identified along a 560mm section of the line

- Technowrap™ 2K glass fibre with hightemperature resin was used to provide structural capability at up to 220°C
- The use of composites over other methods (i.e. welding) allowed for a combined structural repair & corrosion protection solution with a design life of 20 years

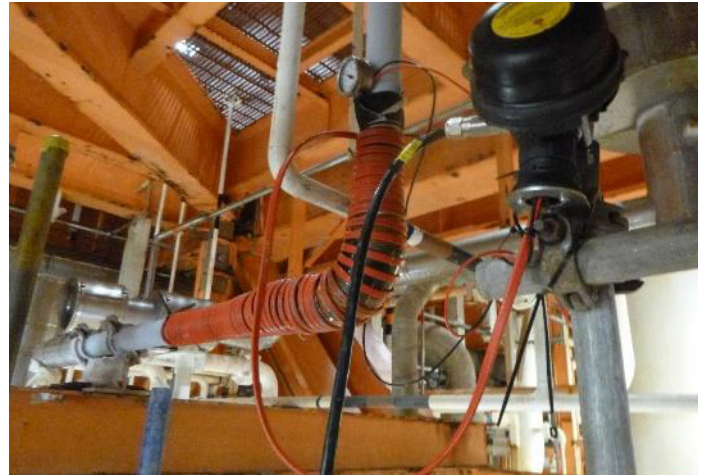
Temperature-controlled heat tape was used for careful control of the resin curing process

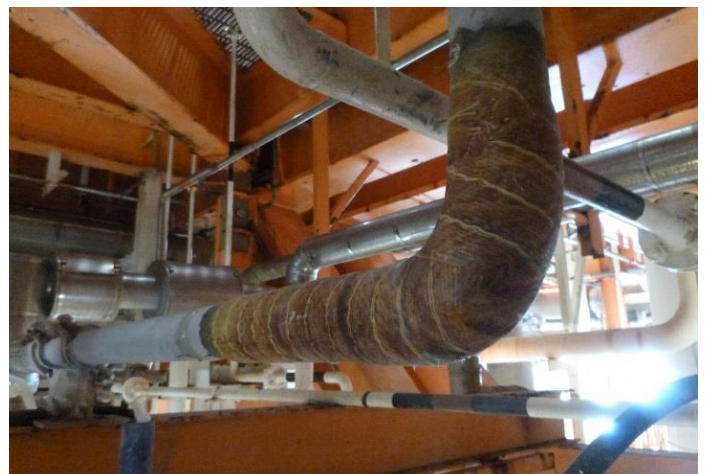
Technowrap™ SRS glass fibre with HT high temperature resin will maintain strength at operating temperatures
