## HT Crude Surge Tank Nozzle

### Overview

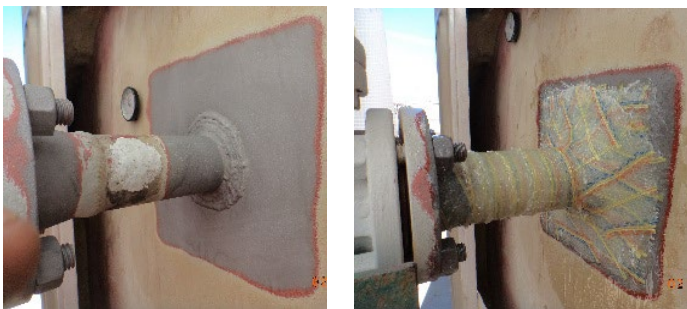
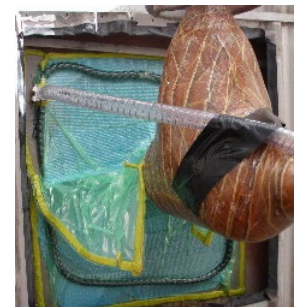
A valve on a crude surge tank had developed a through wall defect in one spot and the surrounding area had minimal wall thickness. The nozzle and valve needed to remain operational, the through wall defect area was sealed using walker technical techno putty before the valve and nozzle were wrapped landing on the tank surface. The temperature requirement of the HT resin required a heat tape to provide an elevated temperature (80°C) cure.

Design Pressure	1,960kpa
Design Temperature	121°C
Application Temperature	60°C
Surface Preparation	Sa2.5
Design Life	2 years
Wrap Length	650mm
Pipe Diameter	60.3mm
Corrosion Type	Internal / through wall
Defect Details	150mm circumferential slot (complete section loss)
Geometry	Tee (and wrap over valve body)

The repair required post curing for each laminate applied. This was provided by electric heat tapes. The heat tapes required a critical permit for operation.

- Technowrap 2K™ HT system with temperature capability up to 220°C;
- A start-up design was used to bring the line on live as early as possible (saving two days);
- Heat tape required for elevated temperature cure;
- Design for complex geometry;
- Vacuum application techniques;
- Versatility by delivering by a patch solution rather than a typical wrap repair. This created a more cost effective solution whilst still achieving the desired outcome.
