## Quickflange used for spool replacement on live deck

A drencher system had suffered significant impact damage in multiple locations on an FPSO. A wide range of spool replacements had to be made without impacting on hydrocarbon production. A combination of spools and cut and installed on site Quickflanges were used to complete the full system cut and renew over 5 days.

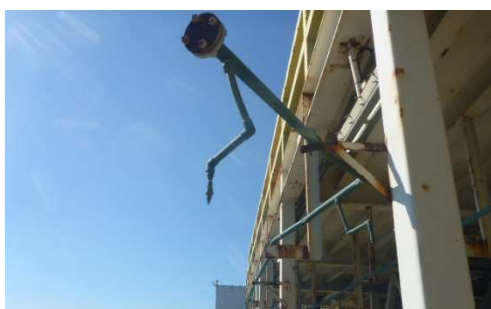
System condition initially

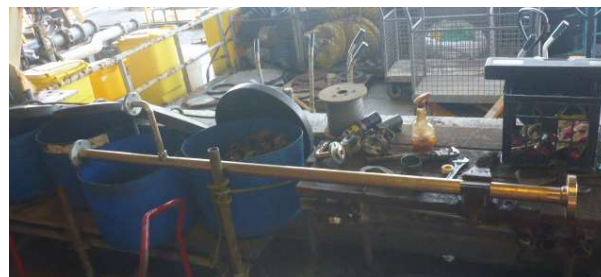
Replacement spools made up on the deck – as required

- Turnkey solution provided with engineering, drafting and spool fabrication completed onshore before offshore Quickflange and spool modification was performed
- Multiple locations were quickly and with reduced cost measured and replaced in one mobilization over 5 days offshore.

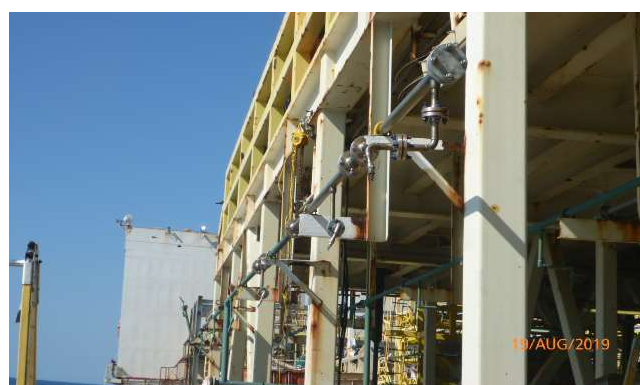
Completed replacements

- No hot work
- Flexibility in the methodology to address latent conditions and residual stresses in the pipework
- Short time on site, 5 days with 2 technicians to complete 5 spools replacements and 14 flange installations.
- DNV approved and ASME code compliant
