Quickflange™ installation on an Ammonia Line

Overview

An ammonia line had internal corrosion on a very difficult to reach section of a tank flare system.

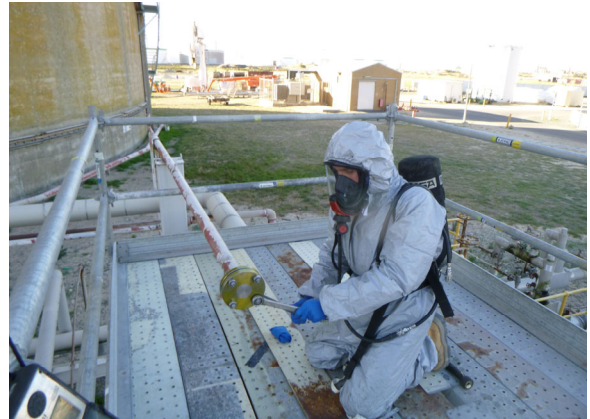
Technician with full breathing apparatus

The ICR.IAS JV were able to solve the problem by removing the corroded section and undertaking a Quickflange™ installation using one of our trained specialists under full breathing apparatus (BA).

- Flanges specified and tested through DNV approved process
- Fully BA trained Quickflange™ specialist to fit with safety requirements
- Adjusted installation procedure to include a secondary isolation point as requested by the client.

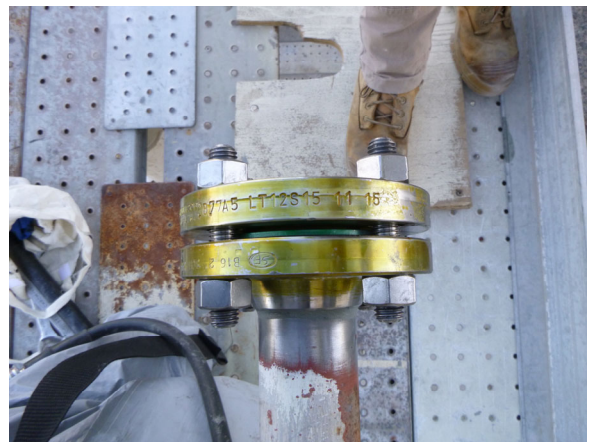
Completed installation including a blind flange

- No hot work
- Completed in one (1) day, reducing shutdown time
- No welding preparation, inspection or habitat requirements
