Live Leak on a High Temperature Amine Line

A 40" Amine Line had suffered stress cracking in the weld line due to vibration and loading conditions during operation.

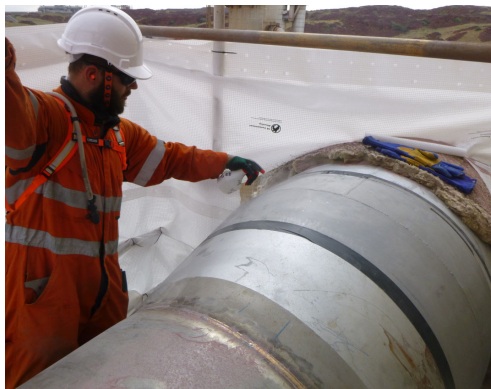
Surface preparation complete

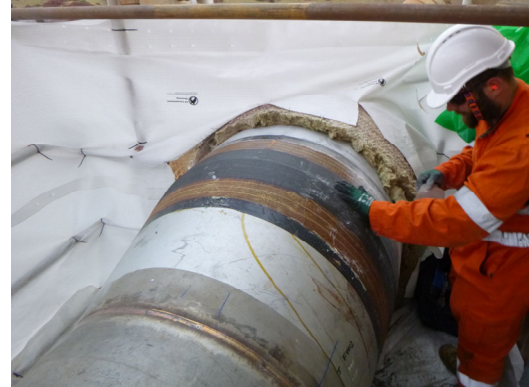
Application of layers

- Technowrap™ 2K HT system with temperature capability up to 220°C
- Carbon Fibre (SRS) selected due to its increased structural rigidity
- Limited landing design to fit within geometric constraints

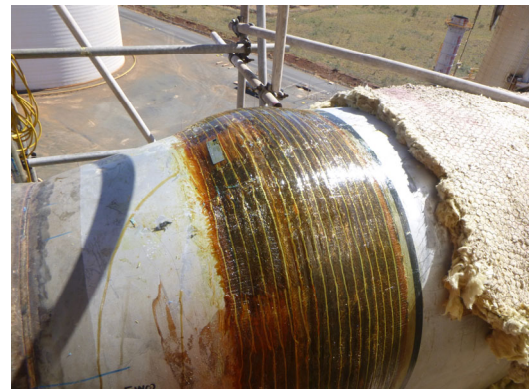
Completed Repair
