Ammonia Tank Dual Nozzle Repair

Overview

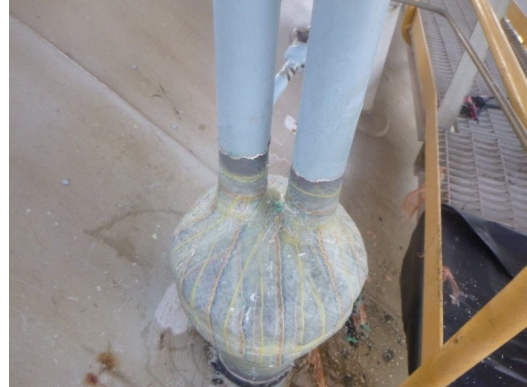
Profiling and initial layer application

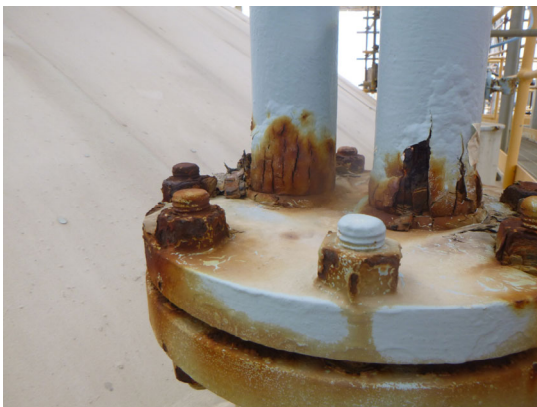
An instrumentation spool located on an Ammonia Storage Tank had severe wall thinning on both outlets of a flange.

Defect locations

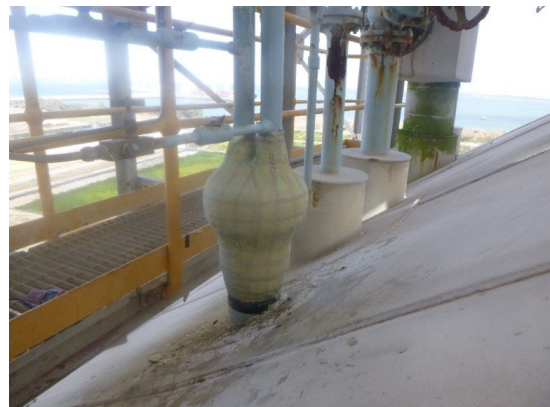
Completed repair

- Technowrap 2K™ HA system with temperature resistance up to 90°C
- Flexible and rapid response providing an engineered composite solution
- Innovative layup procedure to account for the separated landing zones
