High Temperature (HT) Steam Line Repair

Overview

A weld crack was found in a pump room steam line on an FPSO. This line required an in service repair without the use of hot work, met the design temperature of 183°C, and a defect modelled as a circumferential loss of 5mm was required to meet ABS class approval.

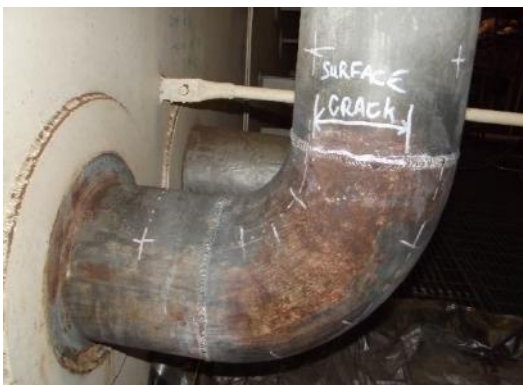
Repair location before surface preparation

- Technowrap™ 2K HT system with temperature capability up to 220°C
- Heat tapes used to provided post cure temperature of 60°C - 80°C
- Crack modelled as complete section loss over weld section
- Spongejet™ surface preparation used for surface preparation

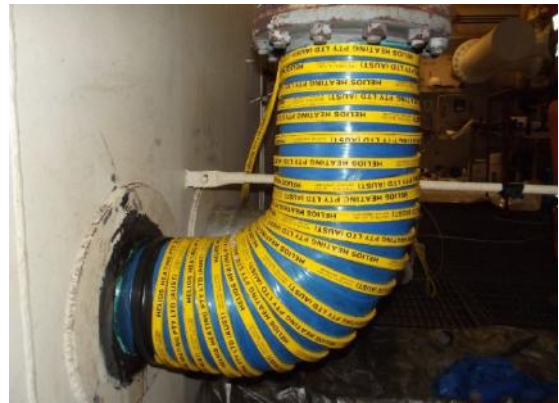
Post curing of repair via heat tapes

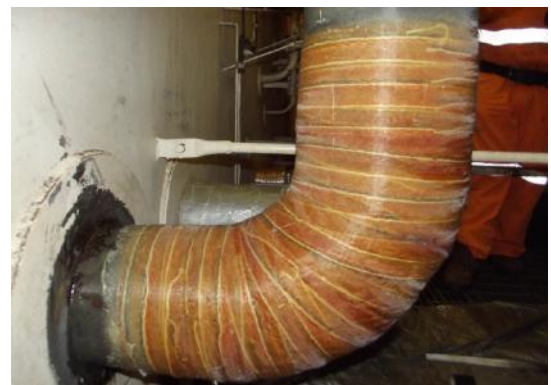
Completed repair

- Spongejet™ fully recyclable system reduced equipment and materials footprint led to improve freight costs
- Start-up design was used to bring line back on line two days quicker
- ABS approved repair
- Technowrap provided both structural loads and pressure containing requirements
