CASE STUDY

Radio Tower Repair

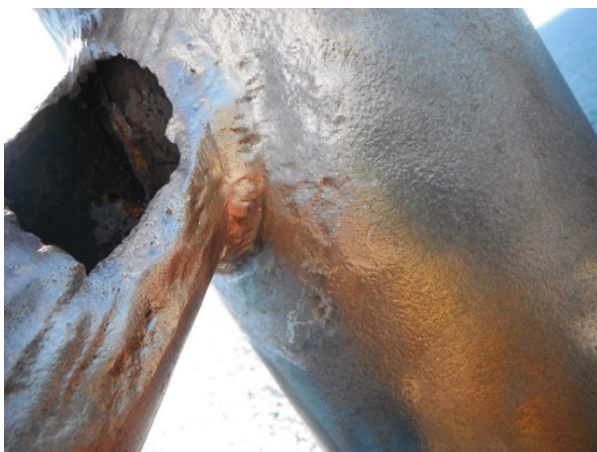
A braced circular column of a Radio Tower suffered significant section loss due to external corrosion. Due to its location on an offshore platform, no hot works were permitted during completion of the repair.

Through-wall defect

- Rope access used to complete surface preparation, application of repair and coating
- Bristle blasters used to prepare the surface to St3 and a surface profile of between 65 and 130 microns
- The large through-wall defects covered with pre-cured sections of Technowrap™ and bonded in place to act as a former for the Technowrap™ SRS

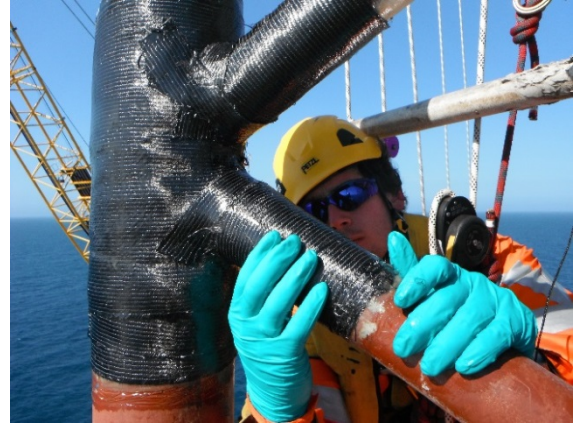
Application of Technowrap™ SRS

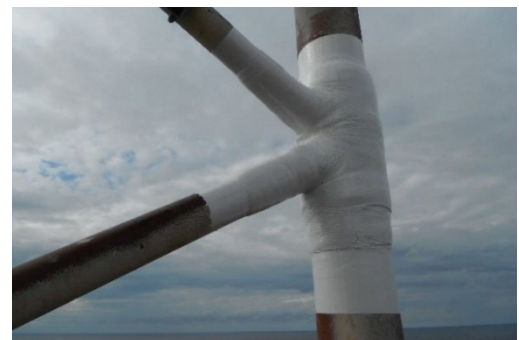
Completed Technowrap™ SRS repair with coating
