## Tank Roof – Surface refresh & pressure containing repairs

The roof of a 14m diameter Ammonia Tank had experienced significant wall thinning due to external corrosion and coating breakdown. Technowrap™ patches were applied in accordance with ISO 24817 to defect locations requiring pressure containment and the whole tank roof coating was refreshed. IC Integrity supplied a 4 man multi-skilled team able to perform “low dust” blasting surface preparation, coating and Technowrap™ repairs.

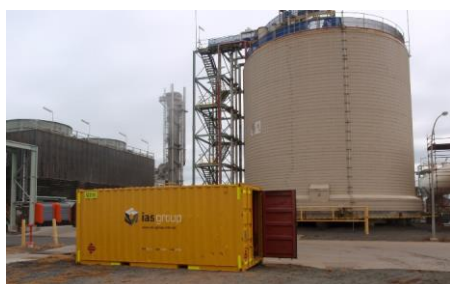
Ammonia Tank Roof Repair

Structure	Tank Roof
Scope	Technowrap pressure containment repairs and protective coating refresh
Surface Preparation	Sa2.5
Technowrap™ Fibre	Carbon (triaxial) Glass (triaxial)
Design Pressure	0.14bar
Design Temperature	75°C
Design Life	20 years
Wrap / Repair Length	500mm square patches
Number of Patches	18
Defect Diameter	50mm
Defect Type	Multiple through wall defects
Design Code	ISO 24817

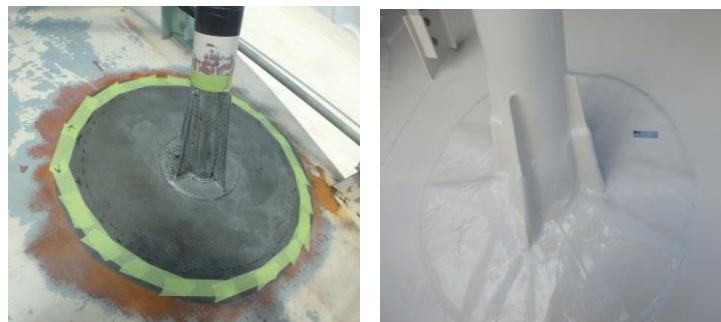
Technowrap™ Roof Patch Repair

- Combination of Technowrap™ fibre types used to deliver the pressure containment and structural requirements, minimizing material and labour costs
- A multi-skilled integrated site team to reduce costs
- SpongeJet™ low dust dry abrasive blasting
- Over coated existing paint and Technowrap™ repairs for continuous high performance coating system

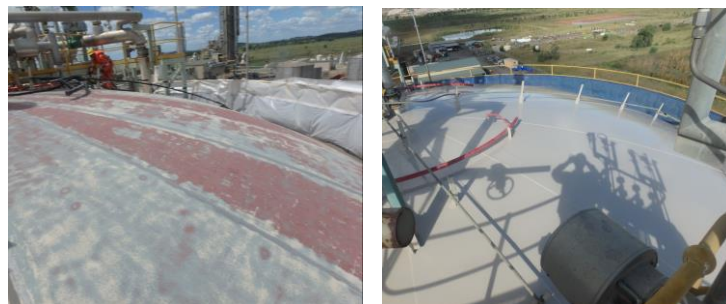
Before and After Tank Roof Refresh
